RE: US DOE Mound Plant, Miamisburg, Ohio
Five-Year Review Report

Five-Year Review Report

Second Five-Year Review for the Mound, Ohio, Site Miamisburg, Ohio

September 2006

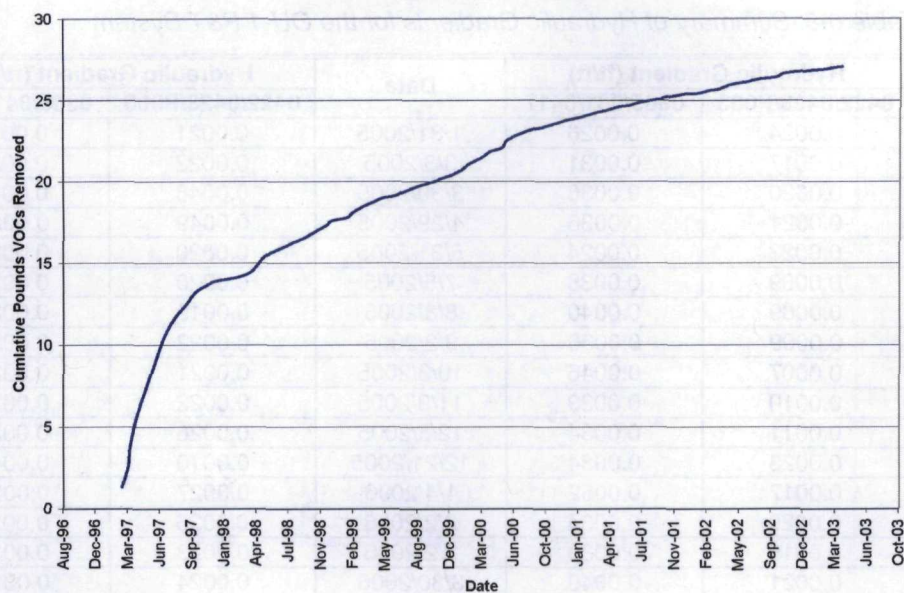
The VOC contaminants of concern have been monitored monthly on both the influent and effluent. The influent concentrations have been used to determine the mass of contaminants removed. This data shows that the P&T system is being effective in the removal of the contaminants of concern (COCs) from the groundwater by the rate of which the mass of the contaminants present in the influent is decreasing. A graph of the mass removed over time is shown in Figure 6-1. The influent concentrations in the 3 extraction wells have also decreased over time (Figures 6-2 through 6-4), indicating that the concentrations within the area of groundwater impact are also decreasing. Increases in VOC concentrations are noted during the rebound test (May 2003 through February 2004). The effluent data demonstrates the effectiveness of the air stripper in removing the COCs from the water being treated. The concentrations of VOCs in the effluent are generally non-detect. These graphs were constructed using the data that were available at the time of this review.

Figure 6-1. Mass Removed by OU-1 Pump and Treatment System

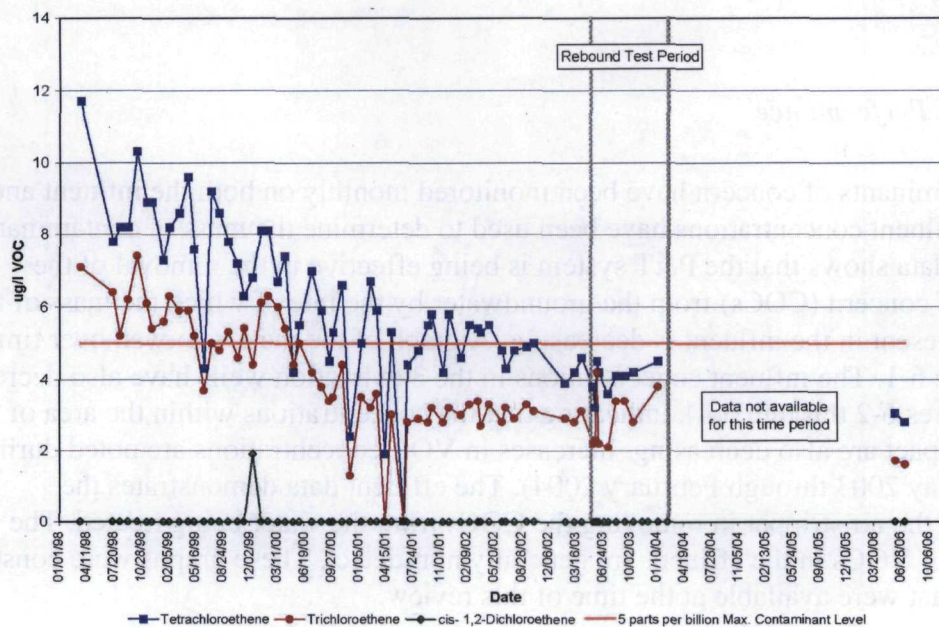
Figure 6-2. VOC Concentrations in Extraction Well 0412

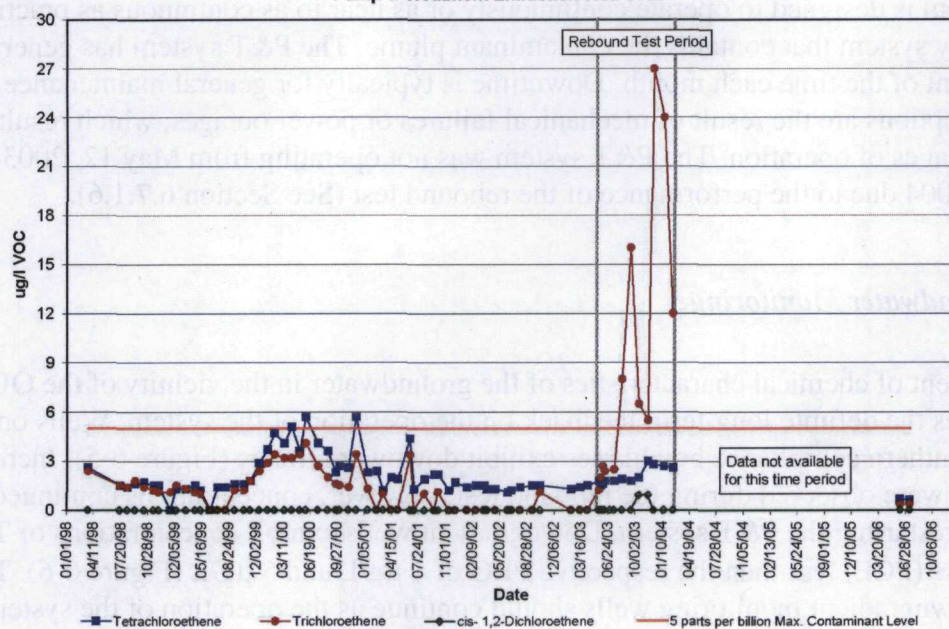
Figure 6-3. VOC Concentrations in Extraction Well 0413

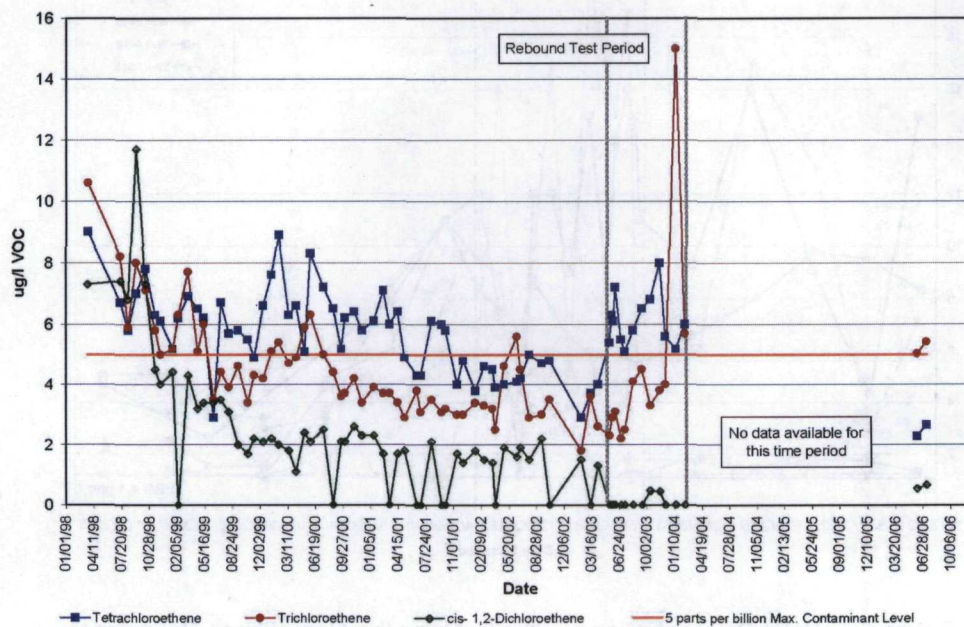
Figure 6-4. VOC Concentrations in Extraction Well 0414

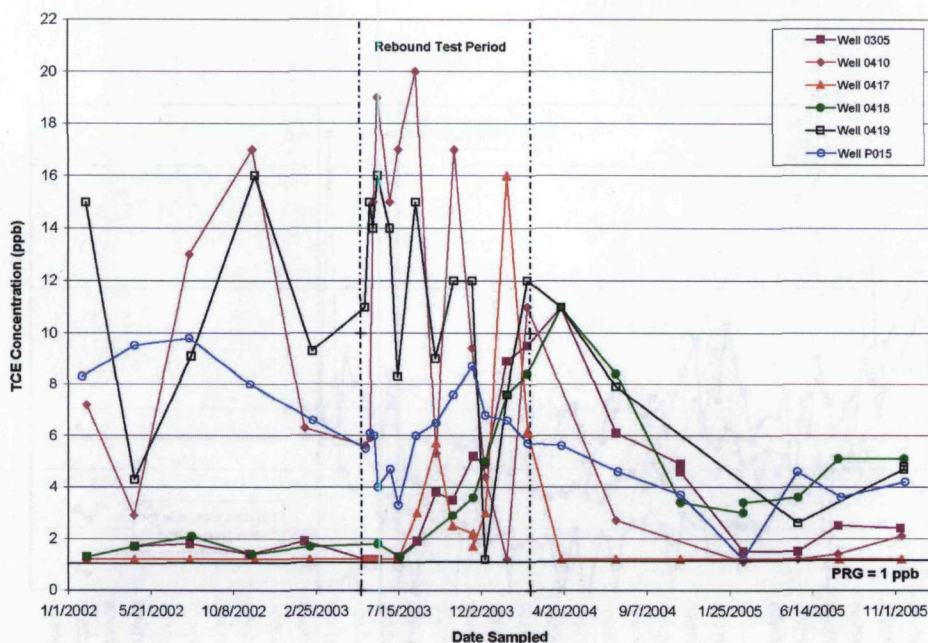
The measurement of chemical characteristics of the groundwater in the vicinity of the OU-1 P&T system provides the definite long-term feedback on the operation of the system. Wells on the western and southern compliance boundaries exhibit downward trends (Figure 6-5). Increased concentrations were observed during the rebound test; however, concentrations continued to decrease after restarting the P&T system. Downgradient wells exhibit concentrations of TCE and Perchloroethene (PCE) less than the respective PRG of 1 µg/L and 5 µg/L (Figure 6-6). This trend in the downgradient monitoring wells should continue as the operation of the system progresses, since the system will cut off the plume from its source.

Figure 6-5. VOC Concentrations in Wells Along the Compliance Boundaries

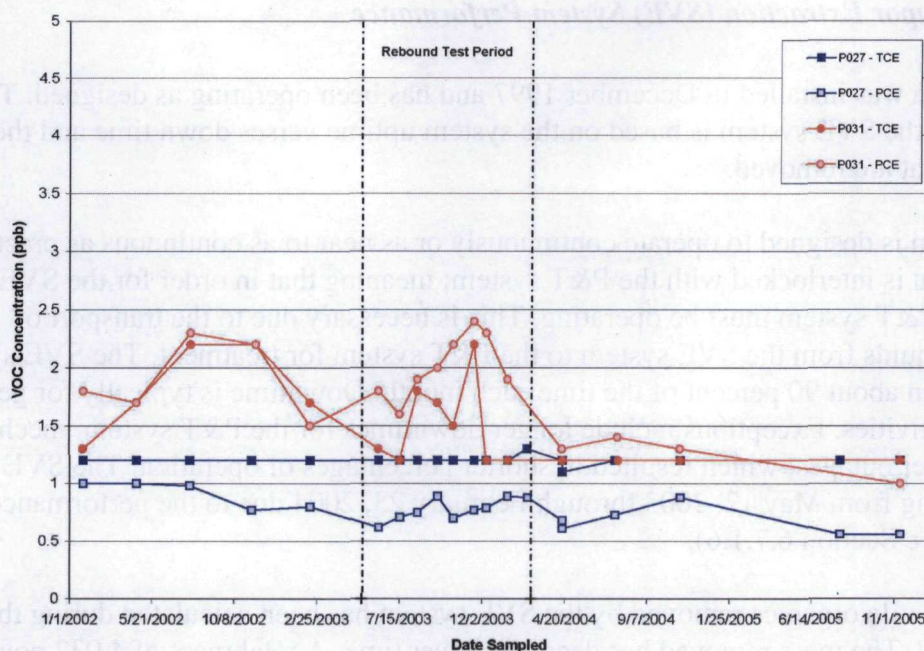
Figure 6-6. VOC Concentrations in Wells Downgradient of OU-1

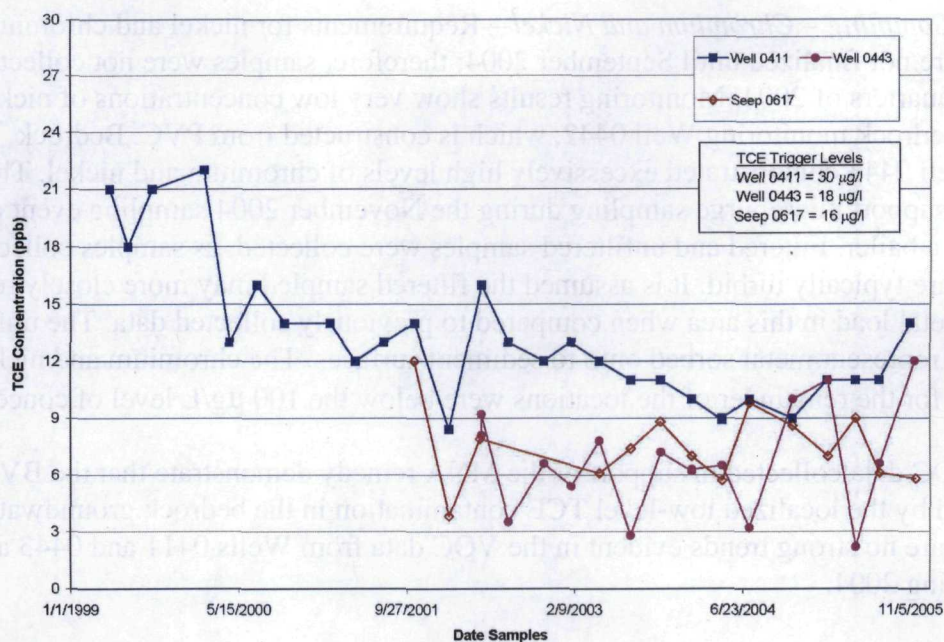
Remedy Monitoring—Monitoring results show continued low-level TCE and cis-1,2-DCE detections in bedrock monitoring Wells 0411 and 0443 as well as bedrock Seep 0617 (Figures 6-7 and 6-8). No detectable concentrations of vinyl chloride were reported. All VOC concentrations remained below trigger levels during 2005. All wells screened in the downgradient BVA groundwater system continue to show no detectable concentrations of VOCs.

Figure 6-7. TCE Concentrations in Wells 0411 and 0443 and Seep 0617 in Phase I

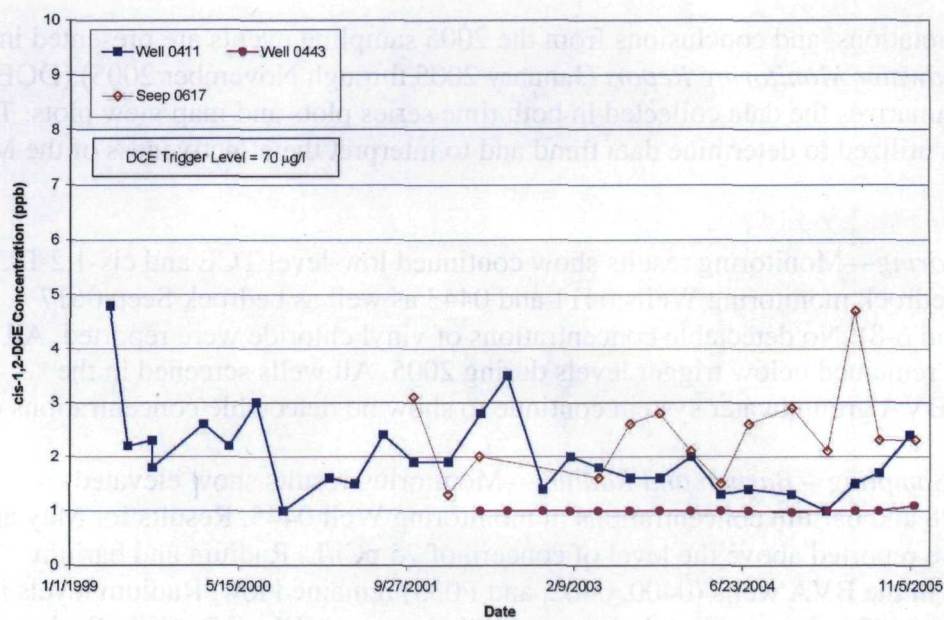
Figure 6-8. cis-1,2-DCE Concentrations in Wells 0411 and 0443 and Seep 0617 in Phase I

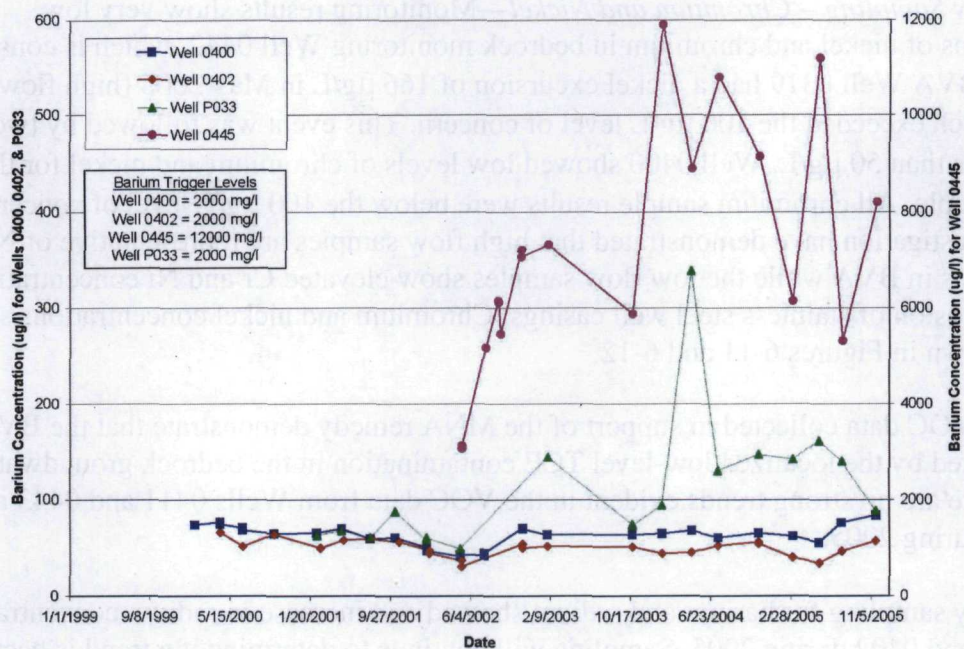
Confirmatory Sampling – Barium and Radium—Monitoring results show elevated radium-226/228 and barium concentrations in monitoring Well 0445. Results for May and November were reported above the level of concern of 75 pCi/L. Radium and barium concentrations in the BVA wells (0400, 0402, and P033) remained low. Radium levels in Wells 0400 and 0402 increase slightly but are still below the MCL of 5 pCi/L. Barium and radium concentrations since 1999 are shown in Figures 6-9 and 6-10. Further monitoring is required to determine if the radium increase in these wells is a trend. The low levels of radium and barium detected in the BVA wells demonstrate that the BVA is not being adversely impacted by the upgradient bedrock water in the vicinity of Well 0445.

Figure 6-9. Barium Concentrations in Wells 0400, 0402, 0445, and P033 in Phase I

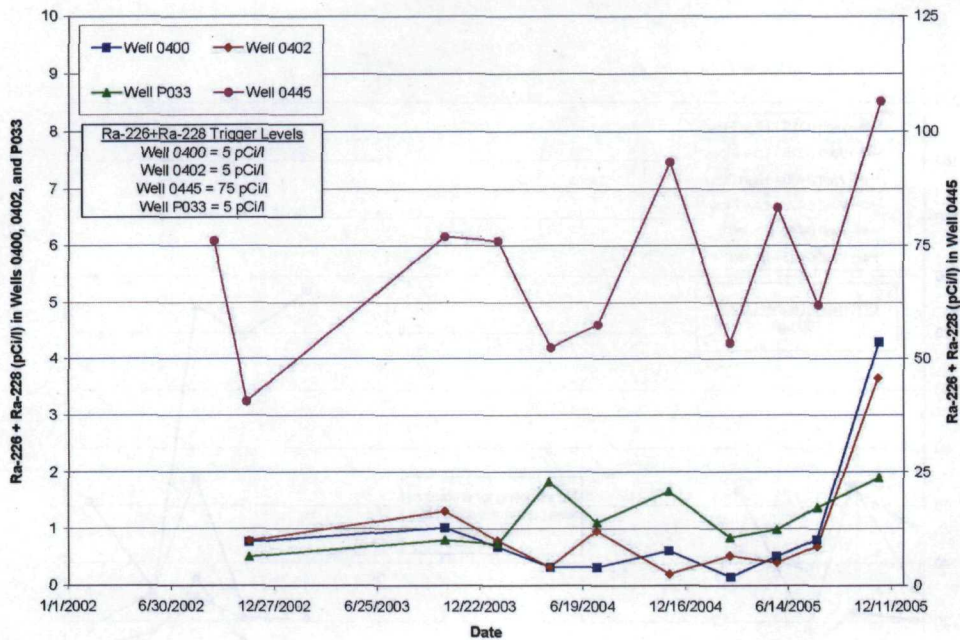
Figure 6-10. Combined Radium 226/228 Concentrations in Wells 0400, 0402, 0445, and P033 in Phase I

Confirmatory sampling for barium and radium showed an increase in radium concentrations at Wells 0400 and 0402 during 2005. Sampling will continue to determine if a trend is occurring at these locations.

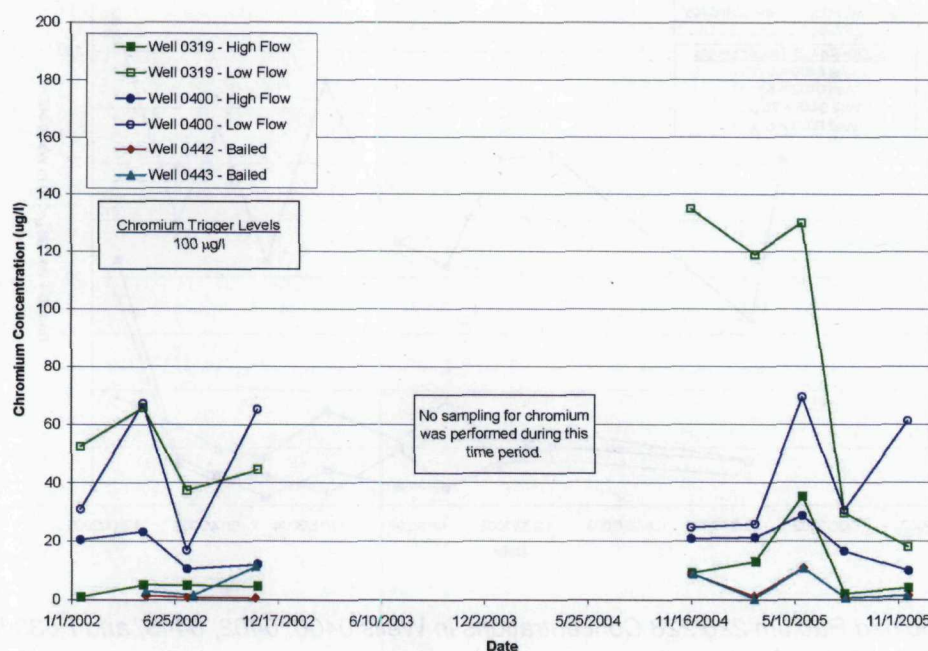
Confirmatory Sampling – Chromium and Nickel—Monitoring results show very low concentrations of nickel and chromium in bedrock monitoring Well 0442, which is constructed from PVC. BVA Well 0319 had a nickel excursion of 166 µg/L in May 2005 (high flow rate sample), which exceeded the 100 µg/L level of concern. This event was followed by two quarters of results less than 50 µg/L. Well 0400 showed low levels of chromium and nickel for the high flow rate sample. All chromium sample results were below the 100 µg/L level of concern. Previous investigation have demonstrated that high flow samples are representative of Ni and Cr concentrations in BVA while the low flow samples show elevated Cr and Ni concentrations as a result of corrosion of stainless steel well casings. Chromium and nickel concentrations since 2002 are shown in Figures 6-11 and 6-12.

Figure 6-11. Chromium Concentrations in Wells 0319, 0400, 0442, and 0443 in Phase I

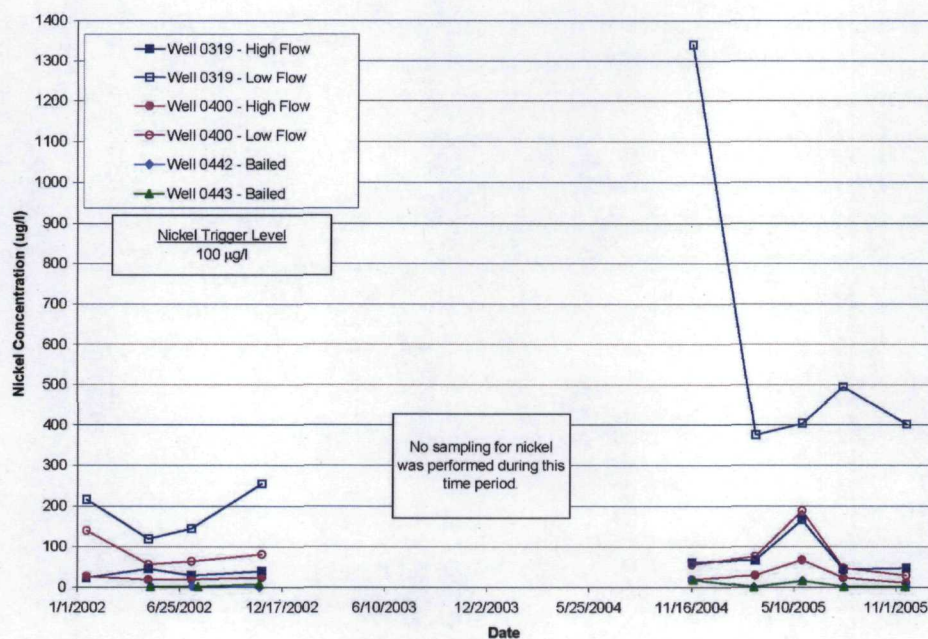
Confirmatory monitoring for nickel and chromium showed one excursion above the level of concern for nickel. The single result for May was not duplicated during 2005. Monitoring will continue to determine if a trend is occurring at this location.

Figure 6-12. Nickel Concentrations in Wells 0319, 0400, 0442, and 0443 in Phase I

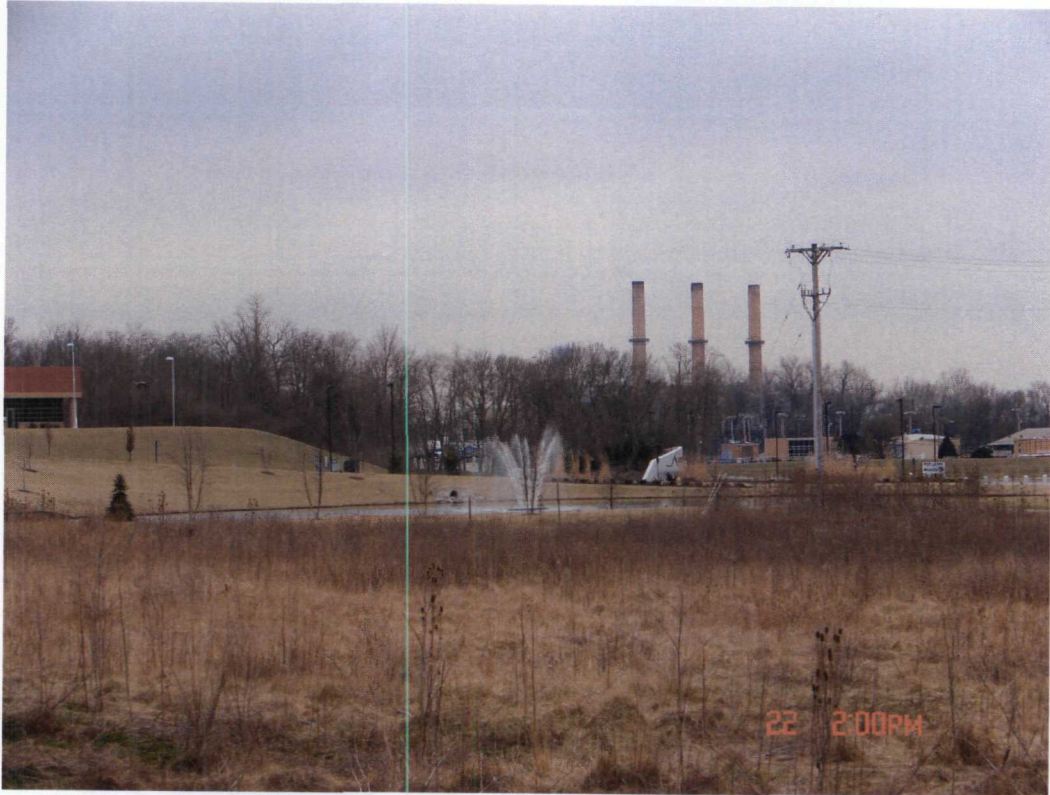
Issue 1: Ineffective signage at the Parcel 4 retention basin has resulted in violation of institutional controls (ICs) in the past (land-use inconsistent with industrial/commercial land-use). (Sections 6.5.4 and 6.5.5).

Retention Basin in Parcel 4

- Adequate signage that informs visitors that fishing, as well as swimming and wading, is prohibited in the Parcel 4 retention basin should be installed.
- Long-term groundwater and seep monitoring locations should be adequately maintained to ensure that representative samples are obtained and to prevent possible impact to the aquifer via surface water infiltration.

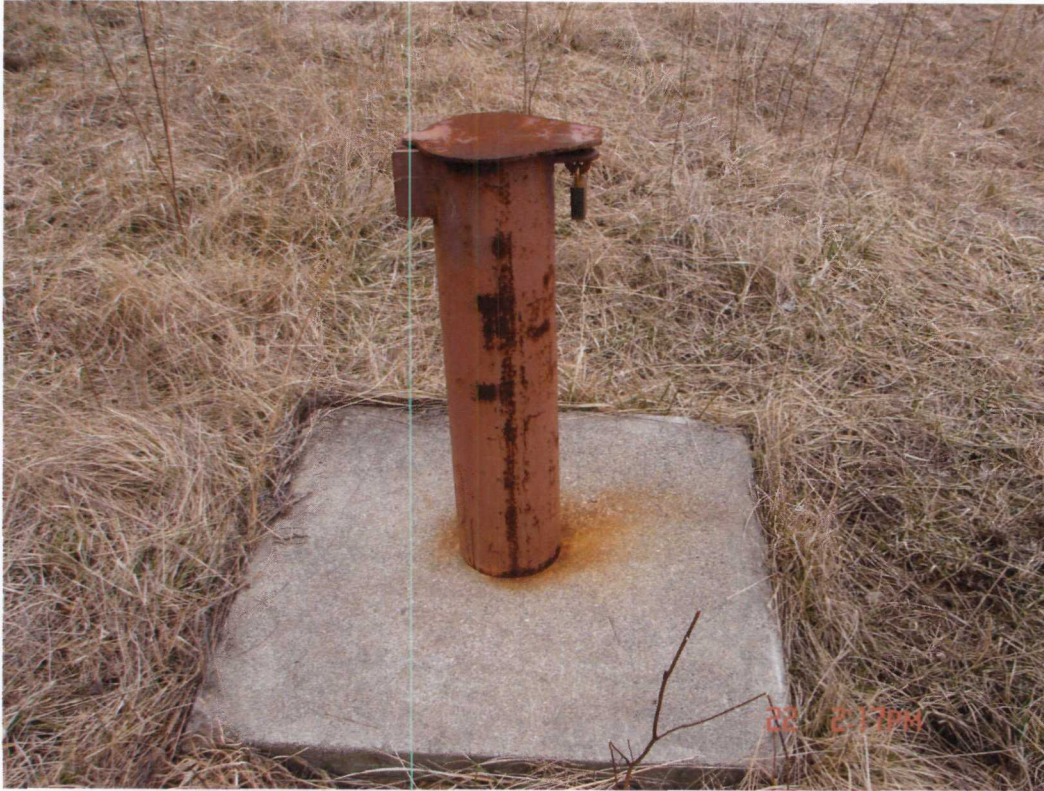
Also, during the walk-over of the Phase I area, the eight groundwater monitoring wells and seep that are included in the *Phase I Remedy (Monitored Natural Attenuation) Groundwater Monitoring Plan* were also inspected. Though not necessary to the protectiveness of the remedy, but as best management practice, the condition of the monitoring wells needs to be improved. The protective casings and concrete pads are in disrepair and many do not have adequate protection (i.e., bollards) from vehicular traffic. Excessive vegetation is present around all the monitoring wells and the seep. Permanent identification markers are missing from Wells 0442, 0445, and P033.

Well 0442 – Phase I

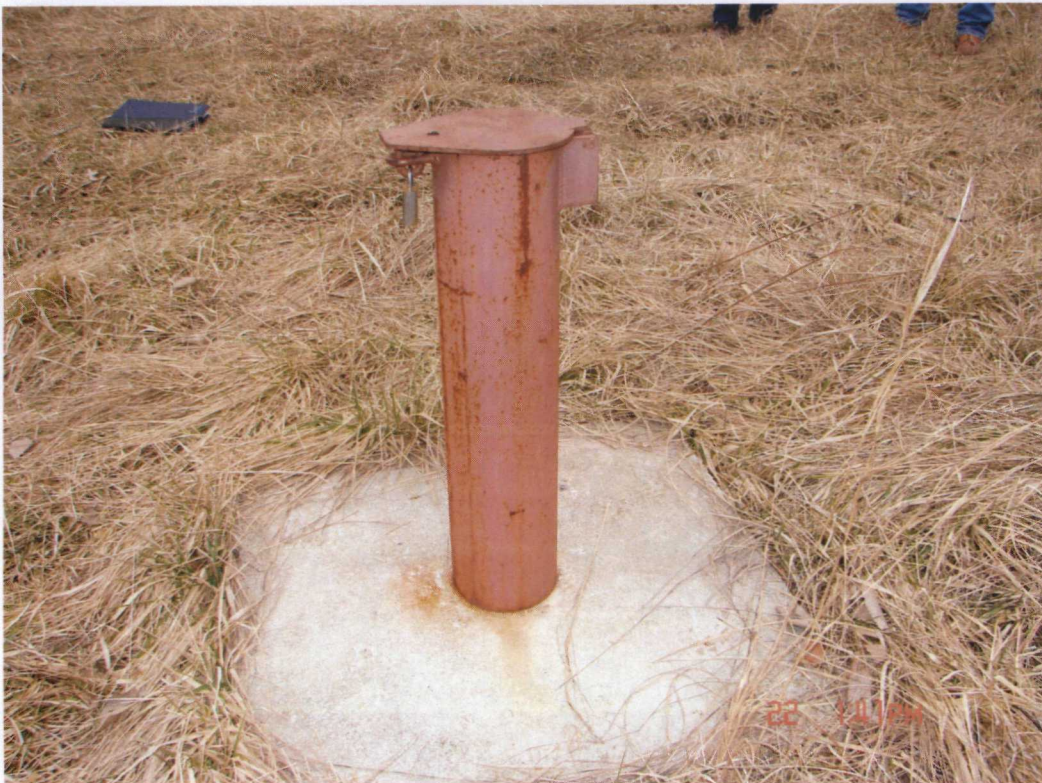
Well 0445 – Phase I

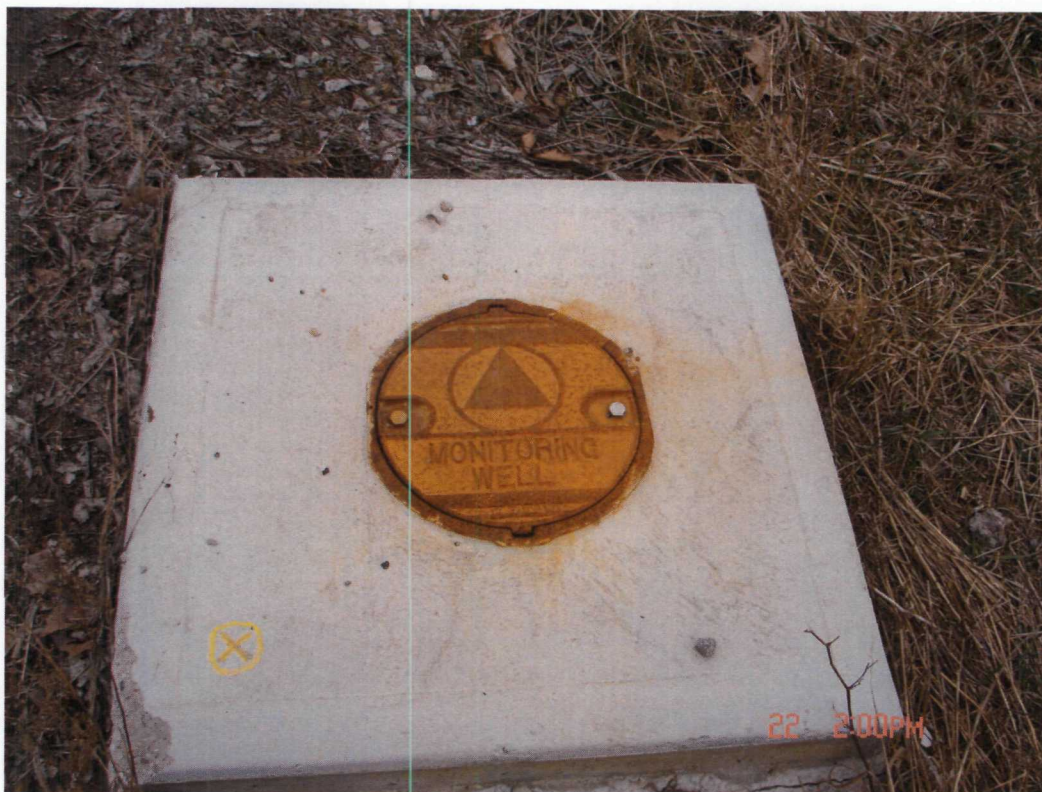
Well P033 – Phase I

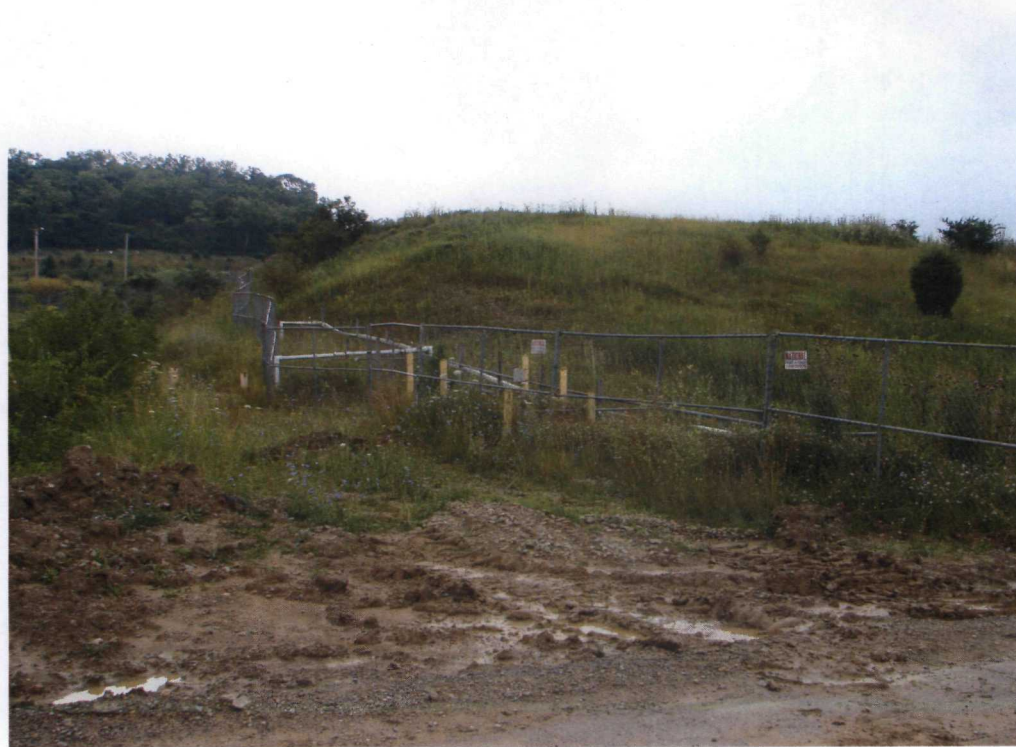
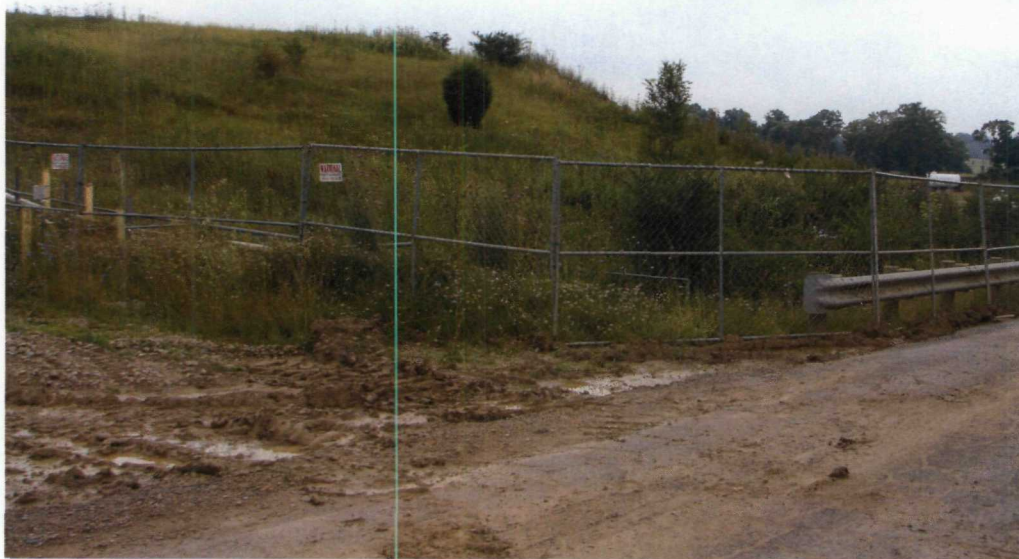
Access and ICs associated with OU-1 consist of fencing around the landfill proper. This fencing is temporary in nature, meaning that it is free standing and not permanently installed with posts secured in concrete. The fencing was in good condition and extended around the complete perimeter of the landfill area.

Fencing along North End of OU-1 Landfill

Fencing along NW Corner of OU-1 Landfill

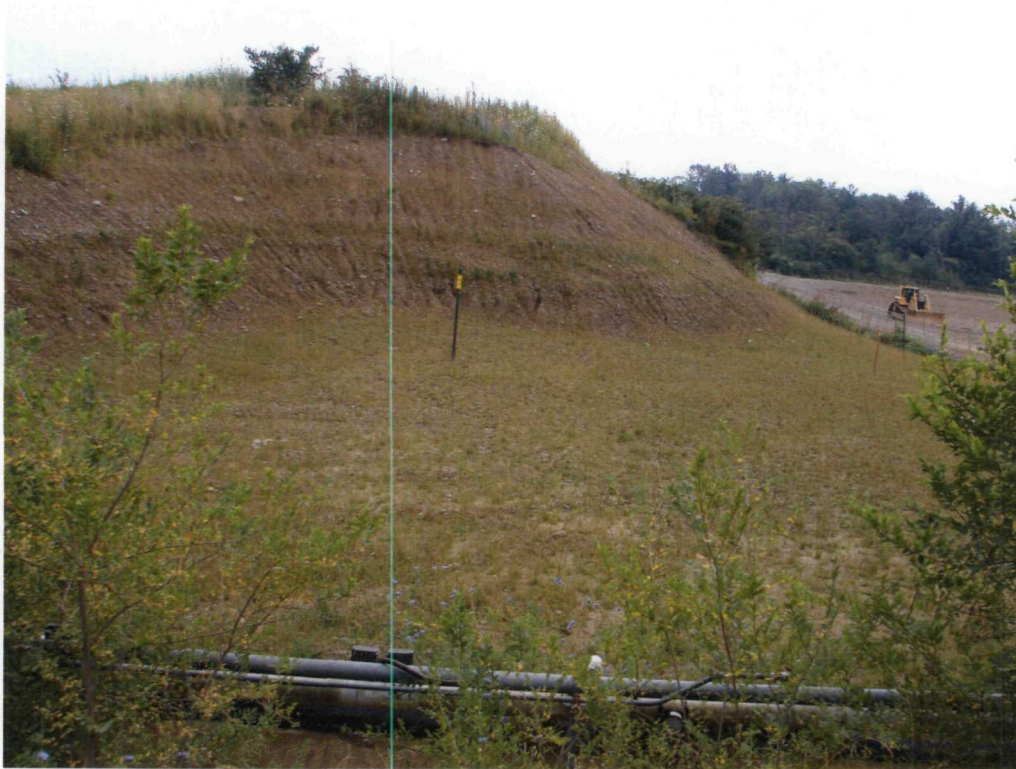
Issue 7: Inadequate stormwater control is maintained on the southwestern corner of the landfill. (Section 6.6.3 and photographs in Appendix B).

The landfill cover is in satisfactory condition. Several small trees were observed on the northern side of the landfill cover. No evidence of slope instability was observed. The southwestern corner of the landfill shows the effects of the recent removal action performed in that area. The area appears to be graded in a fashion to prevent the ponding of water. As note previously, vegetation has not been completely established on the recently excavated areas.

SW Corner of OU-1 Landfill – Looking East

Issue 7. A corrective action should be developed to address the inadequate stormwater controls on the southwestern corner of the OU-1 landfill.

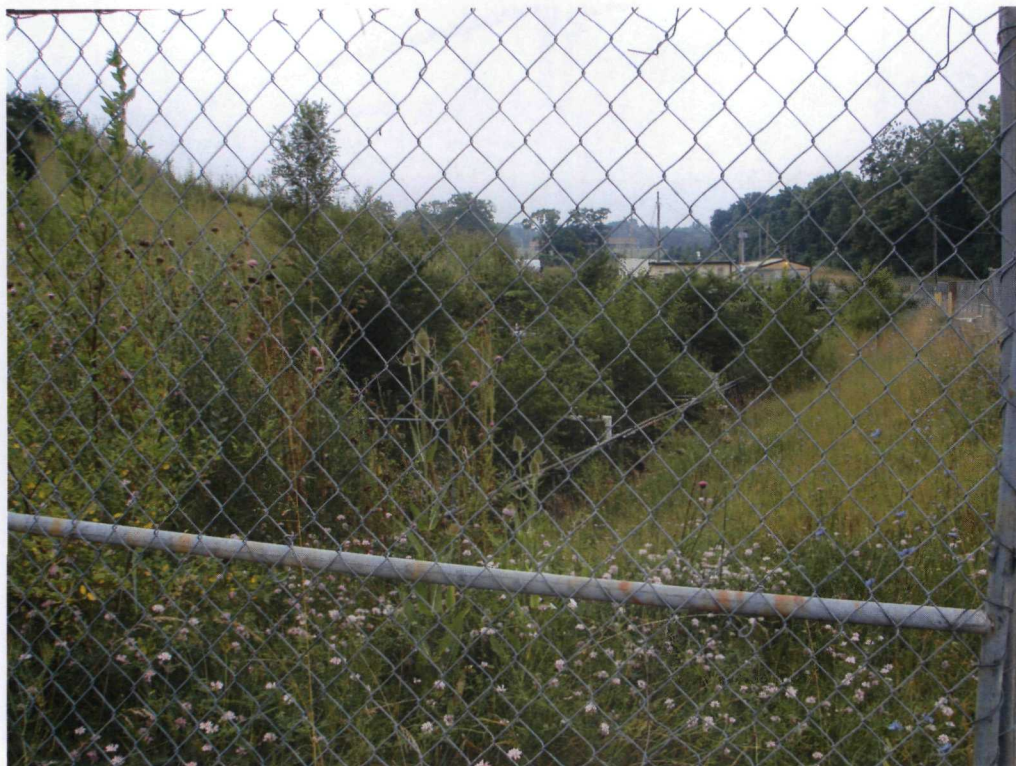
Stormwater along the western side of the landfill is control by concrete lined ditches that discharge to the south and flow beneath the access road near Buildings 300 and 301. Excessive vegetation is present in the ditch that could lead to deterioration of the concrete and impede surface water flow in the future. The drainage in this area has also been impeded by site remediation activities that have resulted in a reduction or elimination of the ditch south of this area. Ponding water was observed in the southwestern corner of the landfill area.

Vegetation in West Concrete Drainage Ditch and SVE Piping

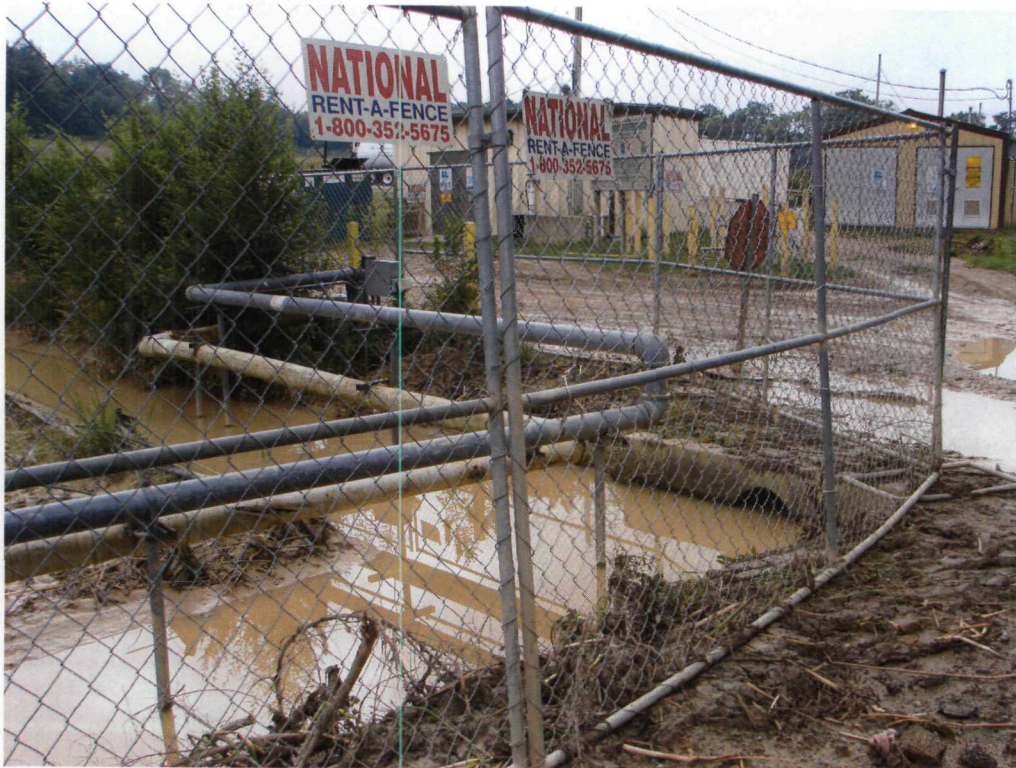
Drainage at SW Corner of OU-1 Landfill

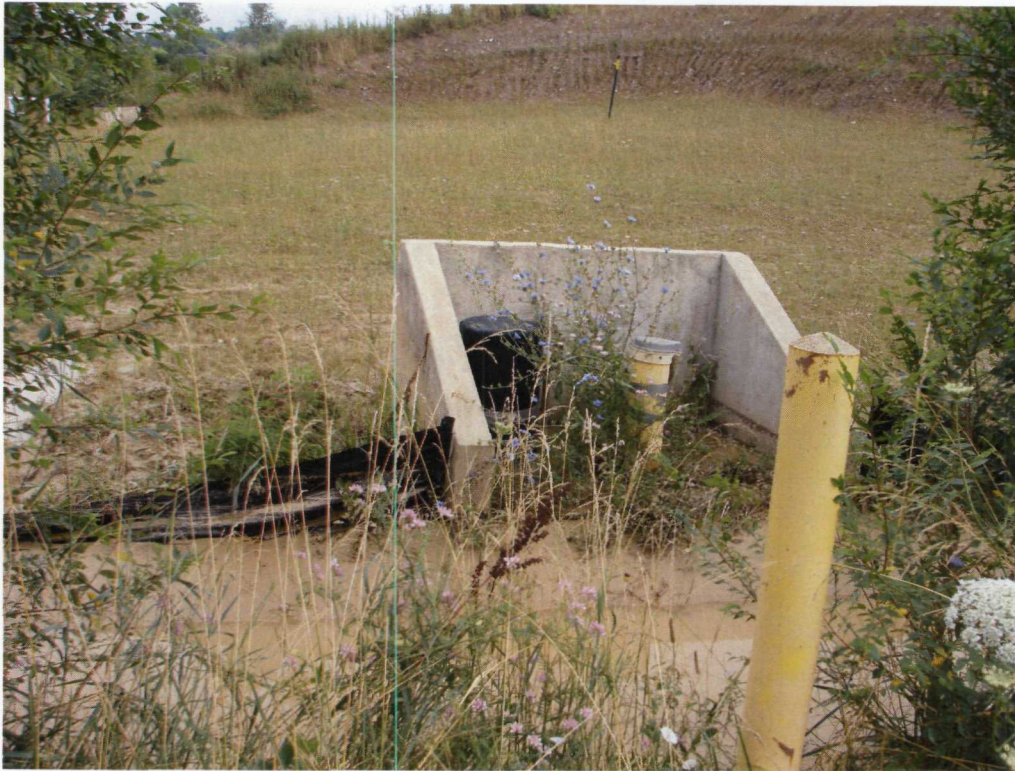
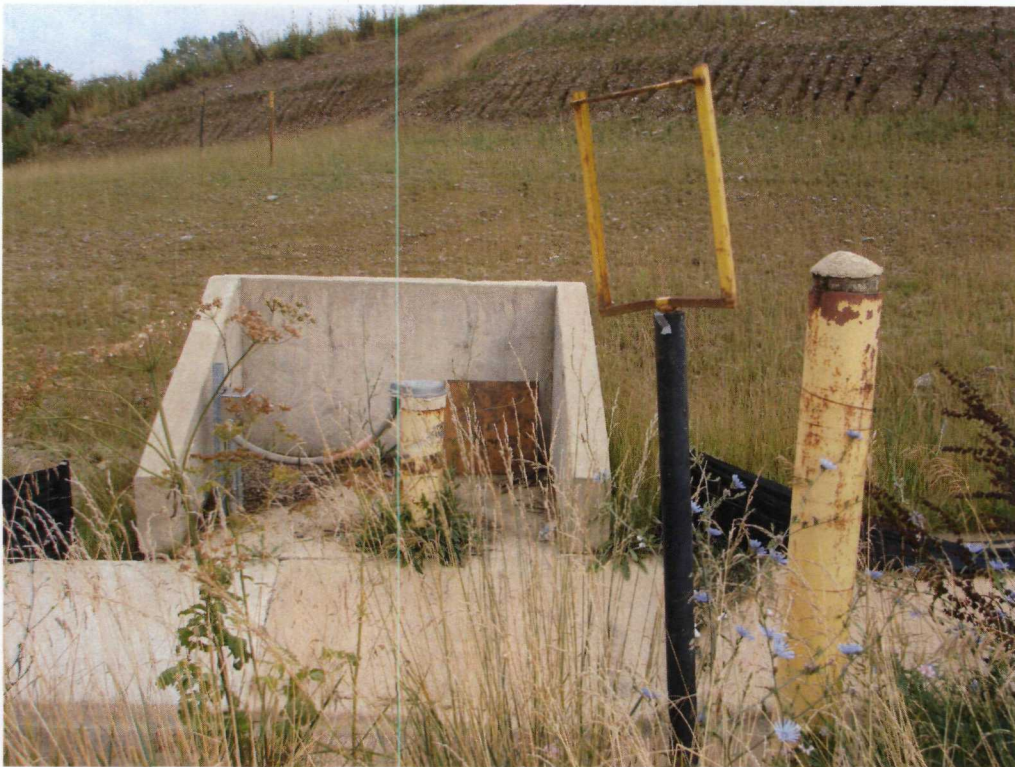
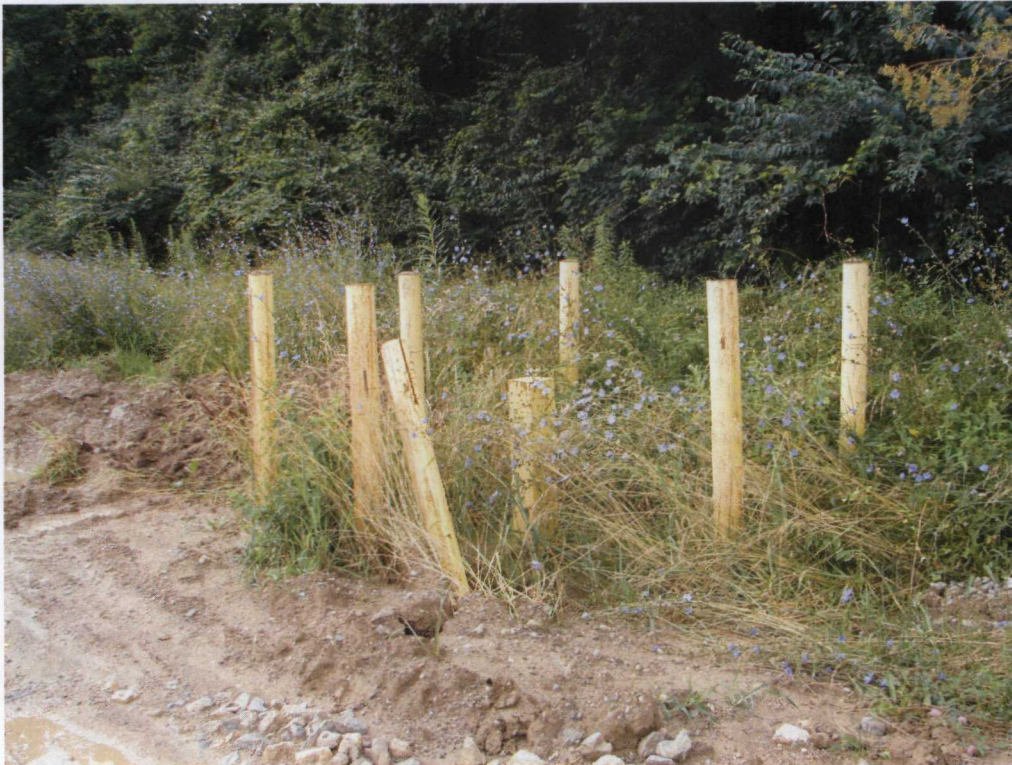
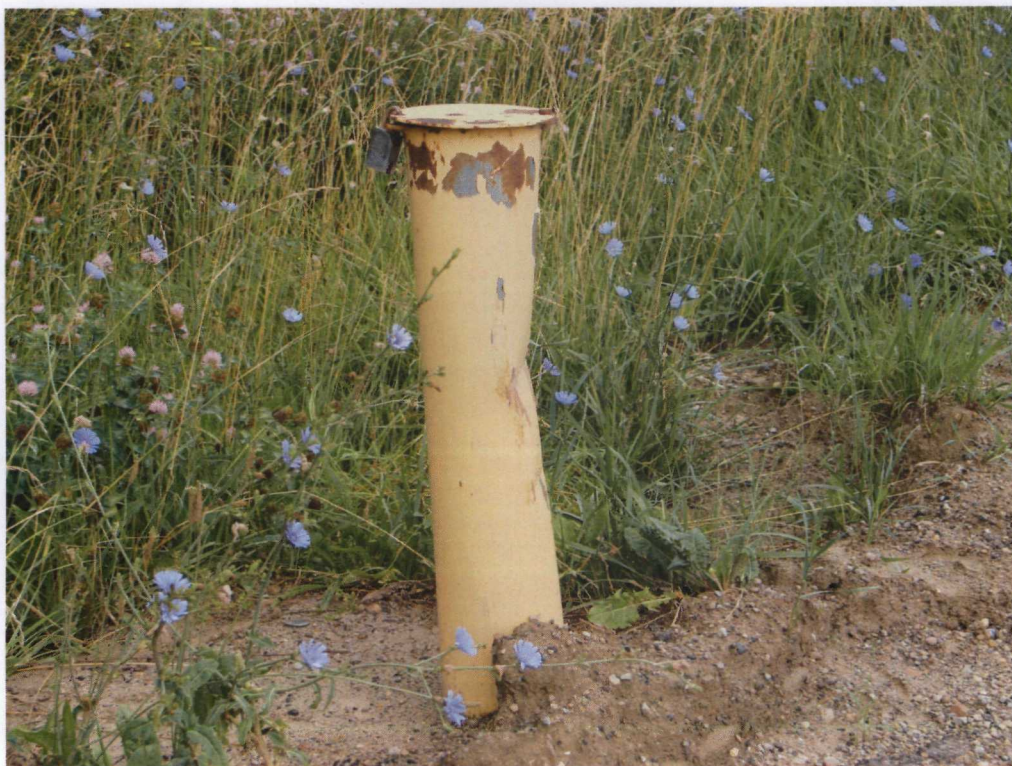
During the walk-over of the OU-1 area, the groundwater monitoring wells that are included in the *OU-1 Pump and Treatment Operations and Maintenance Plan* were also inspected. Though not necessary to the protectiveness of the remedy, but as best management practice, the condition of the monitoring wells needs to be improved. The protective casings and concrete pads are in disrepair and many do not have adequate protect (i.e., bollards) from vehicular traffic. Excessive vegetation is present around all the monitoring wells.

Well 0413 – OU-1 Area

Well 0414 – OU-1 Area

Well 0416 – OU-1 Area

Well 0423 – OU-1 Area
